**A Review of Australian and
New Zealand Investigations
on Aeronautical Fatigue
During the Period April 2001
to March 2003**

DSTO-TN-0489

Air Vehicles Division
Platforms Sciences Laboratory

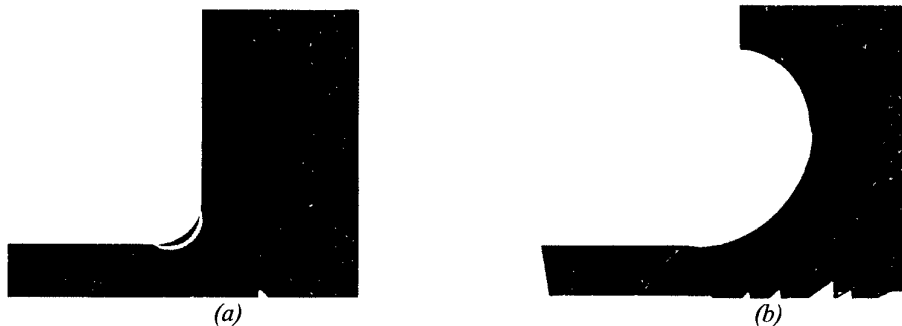
Figure 20: Local distribution of maximum principal stress for F-111 WPF bush: (a) nominal fillet, and (b) optimal non-circular shaped fillet (both rotated by 90 degrees clockwise, as compared to Figure 19).
